Polyamide Coating as a Potential Protective Layer Against Corrosion of Iron Artifacts

Various tools were used in the investigation and analysis processes of the iron window grille of sabil Ramadan. Metallographic Microscope, SEM-EDS Microscope, Carbon-Sulfur, and XRD analysis indicated that the iron window grille was manufactured from low carbon steel. X-ray diffraction of corrosion products showed that they mainly consist of Magnetite Fe_3O_4 , Goethite $\alpha\text{-FeO(OH)}$, and Akaganeite $\beta\text{-FeO(OH)}$. Such information regarding the iron window may assist in the conservation process of this iron window. Coatings and inhibitors are used in a wide range in this field, where Special methods are required either for protection or treatment to stop or reduce corrosion rate. Experiments were performed on coupons simulating iron window to evaluate the efficiency of polyamide by using electrochemical techniques (electrochemical impedance spectroscopy (EIS) and polarization resistance (RP)). It gave sufficient protection and good results of the electrochemical measurements. Tannic acid diluted in 5% methyl alcohol (coating) and polyamide (inhibitor) applied to protect the iro

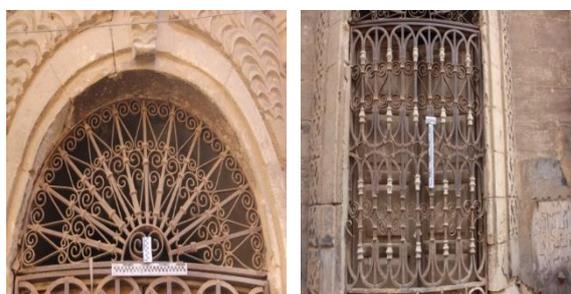
Fig. 2: showing corrosion products and dust particles accumulated on the iron surface of the window grille.

The iron window grille of Sabil Ramadan is exposed to atmospheric agents where the surface was covered with dirt and dust above the corrosion products. By visual examination, it can be noted that components of the iron window grille were joined using mechanical joints (collars, rivets) A rivet is essentially a flat-headed pin that grips two pieces of metal together through the middle, and collars achieve a similar result by wrapping tightly around two or more parallel pieces [9]. Cast iron is often joined using bolts or leaded sockets, whereas riveting indicates either wrought iron or steel [10]. The iron

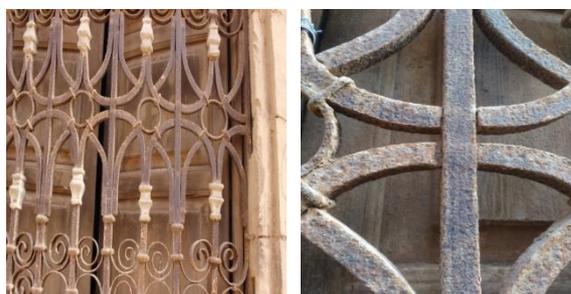
Fig. 3: Window grille components were joined by using iron collars, rivets, and connectors.

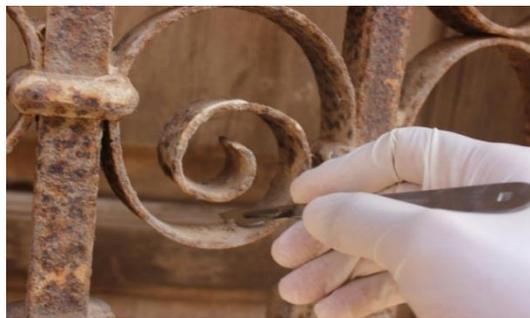
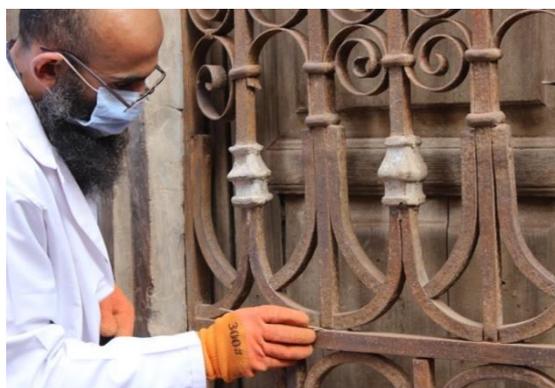
Fig. 8: Scalpels and needles were used to remove dust layer and corrosion products which disappear iron window grille details.

Should be taken into the account avoid making any scratches on the iron surface during cleaning processes [25]. It was necessary to do cleaning to remove heavy dust layers, atmospheric deposits, and corrosion layers by using hand tool cleaning such as scalpels, brushes, sandpapers, and needles, as can be seen in Fig. 8.

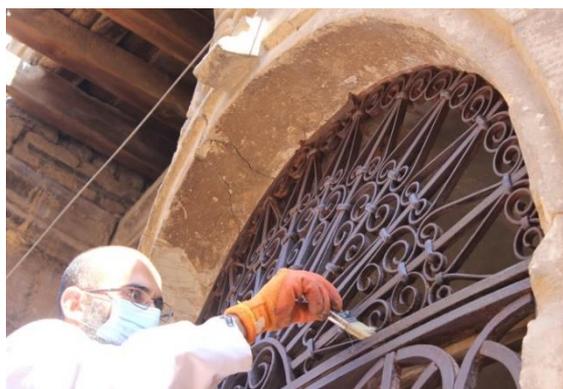
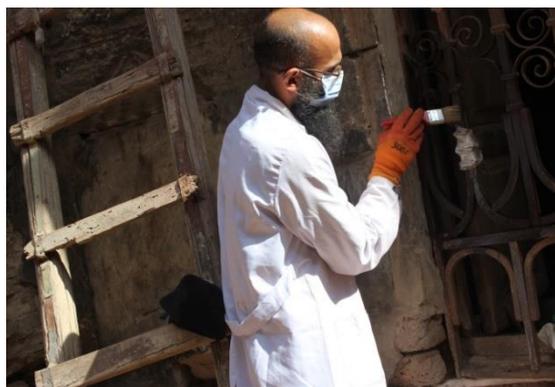
Fig. 9: iron window grille was coated by tannic acid dilutes in alcohol 3% by brush.

Lead connectors were covered by polyethylene to prevent staining from the tannic acid solution. Then, two layers of tannic acid dilute in alcohol 3% (as a pre-treatment) were applied by brush on the iron surface, a layer of tannic acid interacts with iron to form iron tannates. Small brushes were used to confirm penetrating the coating to all the details and the coating is free of any breaks which might expose the iron window grille to the agents of deterioration as seen in Fig. 9. Coatings have been applied in thin layers, allowing each to dry thoroughly before the next coating is applied. This prevents solvents from evaporating from the layer underneath and damaging subsequent coatings applied on top [26-28].

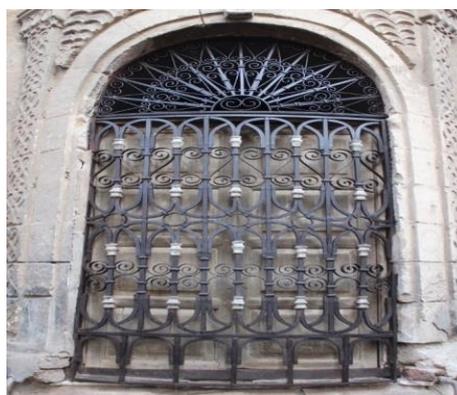
Fig. 10: The iron window grille after conservation treatments

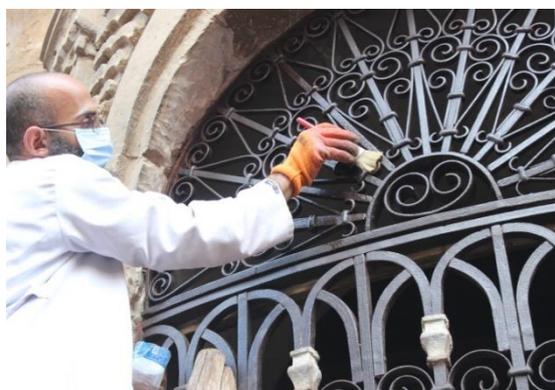
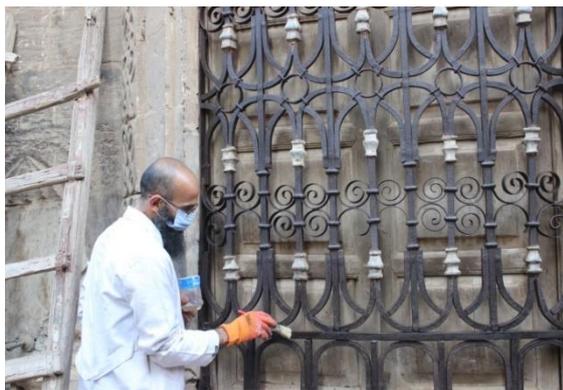
Fig. 11: The iron window grille was coated with polyamide 2% which applied in two layers by brush, from top to down and another layer from right to left

After the tannic acid layer was dried, the inhibitor layer (polyamide 2%) coated on the iron window grille surface by using a brush which gave the best results in the experimental study to prevent further corrosion in the future. Small brushes were used to confirm penetrating the inhibitors to all the details and the coating is free of any breaks which might expose the iron window grille to the agents of deterioration. It has been applied two layers by brush: one from the top to down and another from right to left, as shown in Figs. 10,11 [29-33].
